# Thermal Simulation Test for Pad Cut Structure Integrity

## Pad material is not fully cut Issue

## PTM7950 was not thinned down as usual Issue

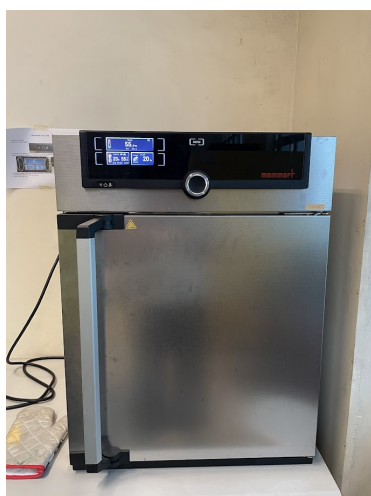
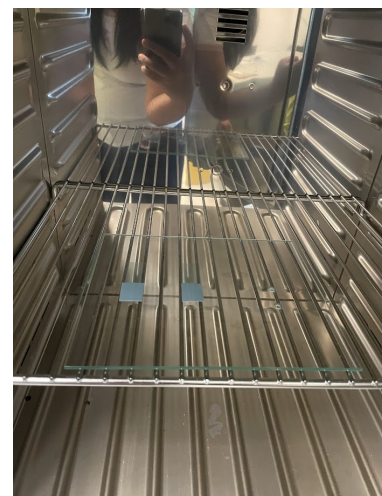
Description: The test aims to evaluate the material's stability at elevated temperatures and determine if melted pads remain workable after cooling. The test involves subjecting two interconnected pads to 55°C, monitoring their condition at specific time intervals up to 5 days. Finally, a manual peel test will be conducted to determine if the pads can still be handled effectively.

Observation: After five days of exposure in a 55°C oven, the pad cuts remained intact, and no oil stains were observed. The result is different compared to the previous 40°C in a roll since there is no load pressure to press the pads thus no sticky issues. **This test confirms that the occurrence of oil stains & melting on some pads is not temperature-related but rather caused by the tension load in reel form.**

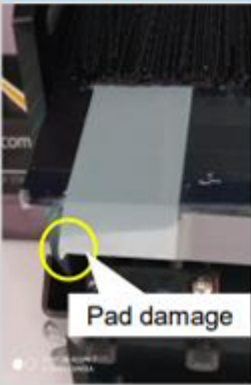
| Simulation test#1 | Test result | Conclusion |
|---|---|---|
| <p>Pick pad <i>down</i> while handling</p> <p>VDO</p> | <p>Result = OK</p> <p>Test result</p> <p>Customer's information</p> | <p>Pick pad <i>down</i> do not make pad damage</p> |

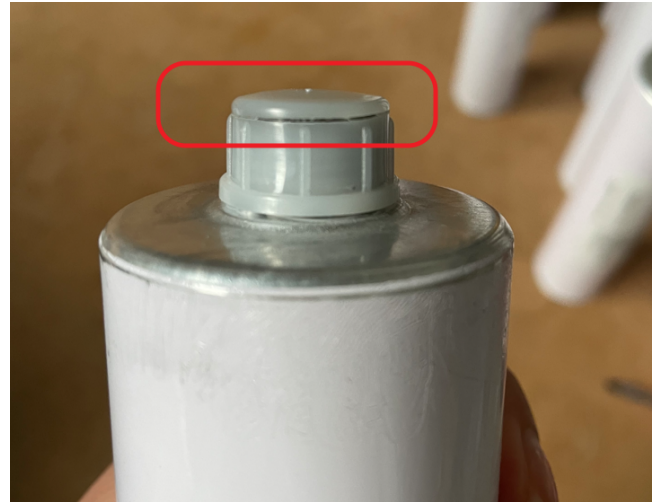
The team encountered in one of the shipments minor signs of leaks due to damaged caps (See pictures below)

Since the PCM paste material contains solvent, there is a high risk of evaporation and viscosity changes if the container cap is damaged. It is strongly recommended to replace the material to ensure consistent performance and reliability.
